Honokowai Water Quality Management Plan

June 2016

Prepared for:
NOAA Coral Reef Conservation Program

Prepared by:
Horsley Witten Group, Inc.

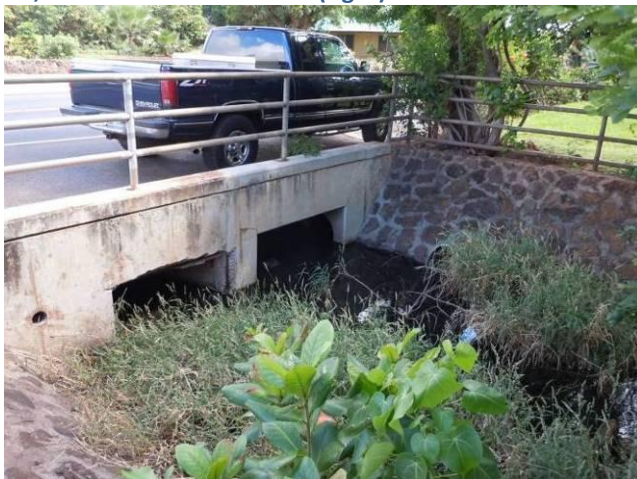
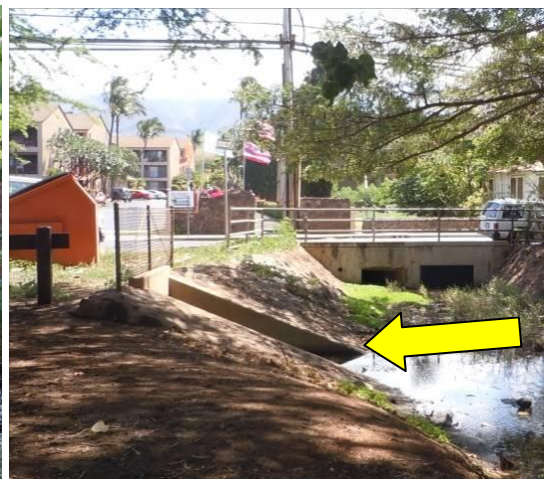
1. HBP 1: 7' x 1.5' concrete box culvert from the north (parallel to Lower Honoapiilani Rd)
2. HBP 2: 4' x 2' concrete box culvert from the east (slight diagonal across Lower Honoapiilani Rd)
3. HBP 3: 5' x 2' concrete box culvert from the southeast (perpendicular to Lower Honoapiilani Rd)

HBP 2 and 3 are box culverts under Lower Honoapiilani Rd (left); HBP 1 is a large box culvert under the parking lot, indicated with an arrow (right).

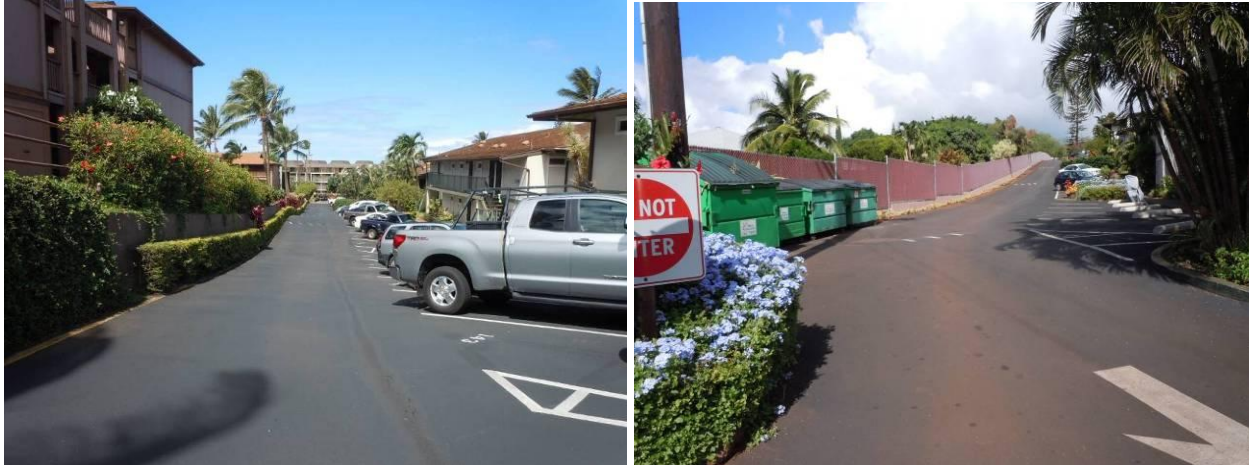
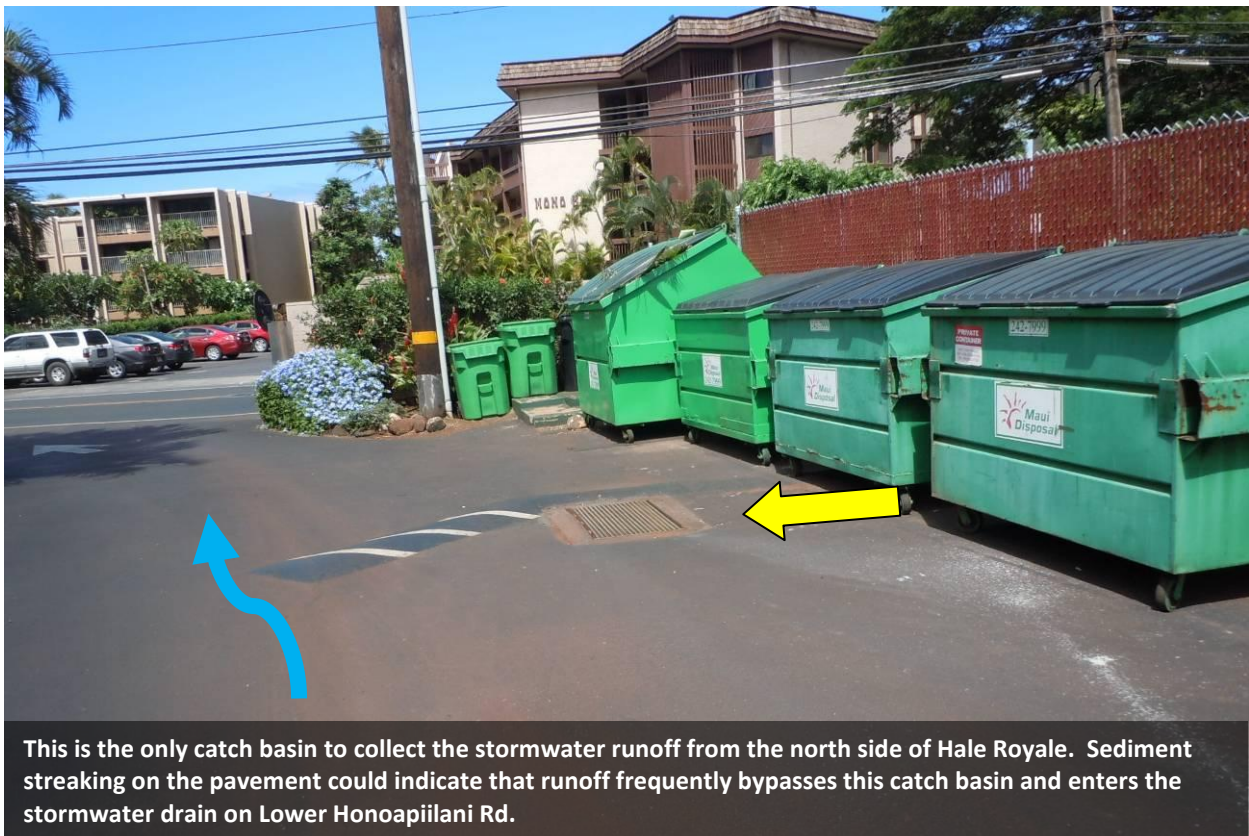
Looking downhill towards the entrance to Hale Royale (left); looking uphill from the exit (right).

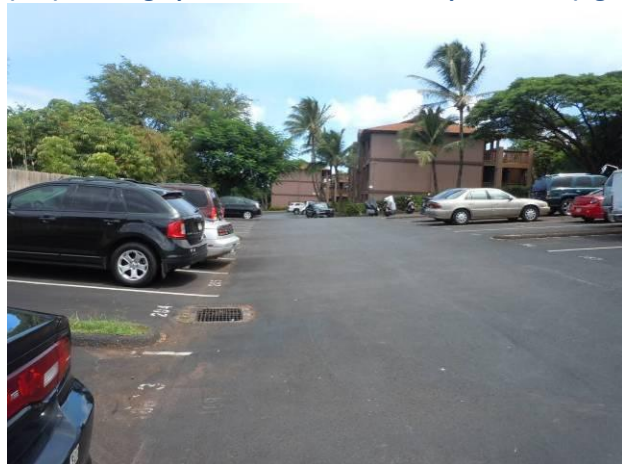
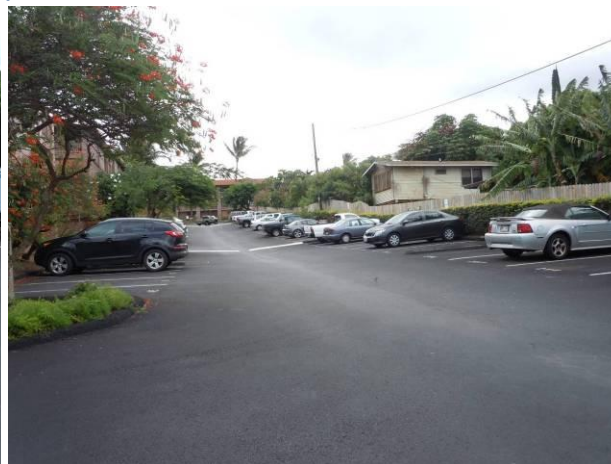
Maui Lani Terraces/Leinani Apartments

Maui Lani Terraces is a large (4 acres, 95% impervious) condominium complex built in 1989, while Leinani Apartments, built in 1970, are less than an acre; they are both accessed from the same driveway off Lower Honoapiilani Rd. Runoff from Leinani Apartments and the entrance portion of the driveway flows into catch basins along Lower Honoapiilani Rd. Runoff from Maui Lani Terraces is collected by catch basins and storm drains that carry the stormwater into the Hale Royale drainage system, which discharges into Mahinahina Stream Watershed. Thus, for small storm events, this development is outside our watershed. However, given the steepness of the parking areas, it is highly likely that at least some of the stormwater from larger storm events will bypass the catch basins and continue to flow down into the street drainage system.

The upper parking lot at Maui Lani Terraces showing the extensive pavement and a catch basin at the low point (left); looking uphill from near Leinani Apartments (right).

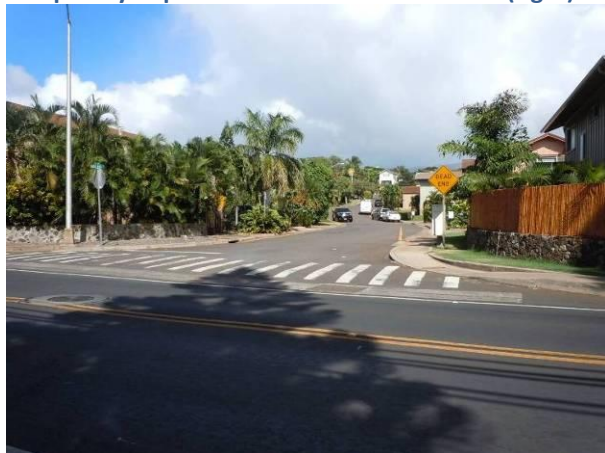
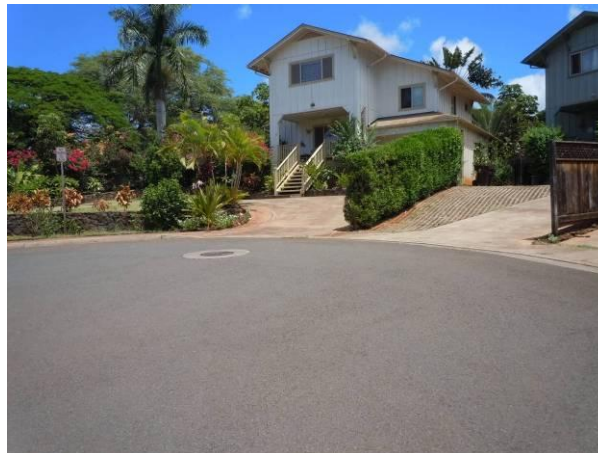
Haku Hale Place - Cul-de-sac

Haku Hale Place is a newer neighborhood than most of the surrounding area (built in 1997). The dead-end road serves 26 houses, with a 60-foot cul-de-sac as a turnaround. The road was designed with two 8-ft wide lanes, and one 8-ft wide on-street parking lane all along the south side. The road is crowned, and stormwater is directed into curb inlets that are connected to the Lower Honoapiilani Rd drainage system, HBP-1.

This road is wider than typical for a two-lane road because a parking lane was included (left); the cul-de-sac is completely impervious with a 60-ft diameter (right).

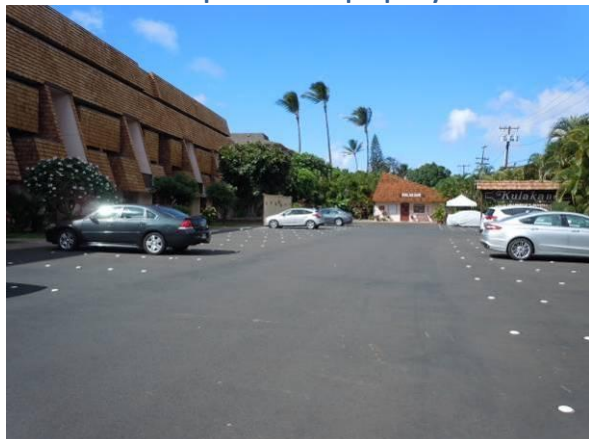
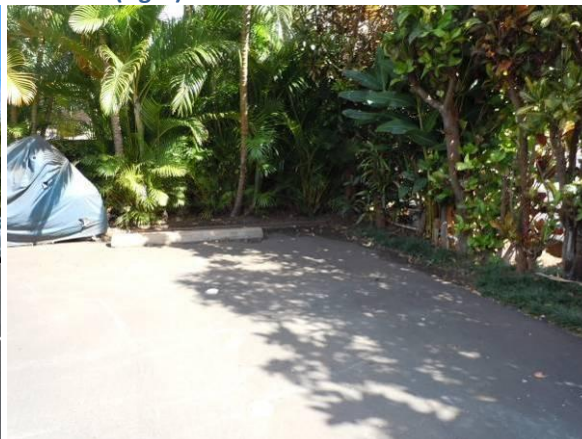
Built in 1970, Kulakane is an oceanfront condominium with almost 0.5 acres in the watershed, 68% of which is impervious parking lot. From the field visit, it appears that the rooftop runoff does not discharge onto the parking lot, but is contained in landscaped areas and/or flows toward the ocean. The large parking lot has no stormwater infrastructure; instead, all of the runoff flows toward the low point at the southeastern corner and out onto Lower Honoapiilani Rd.

The extensive parking lot at Kulakane with no stormwater infrastructure (left); all runoff from the parking area drains to this low point on the property and out into the street (right).

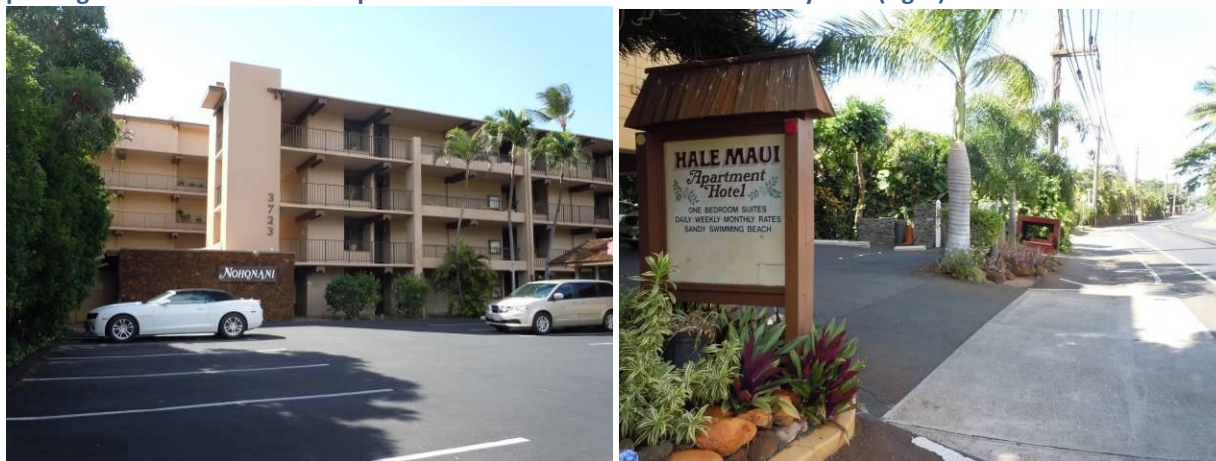
Nohonani Condos and Hale Maui Apartment Hotel

The parking area for the Nohonani Condos and the rooftop from the Hale Maui contribute runoff to the drainage area for HBP-1 without any visible on-site stormwater management. The

The Nohonani Condominiums parking lot drains out to Lower Honoapiilani Rd (left); a portion of the roof and parking area of the Hale Maui Apartment Hotel also drains into our study area (right).

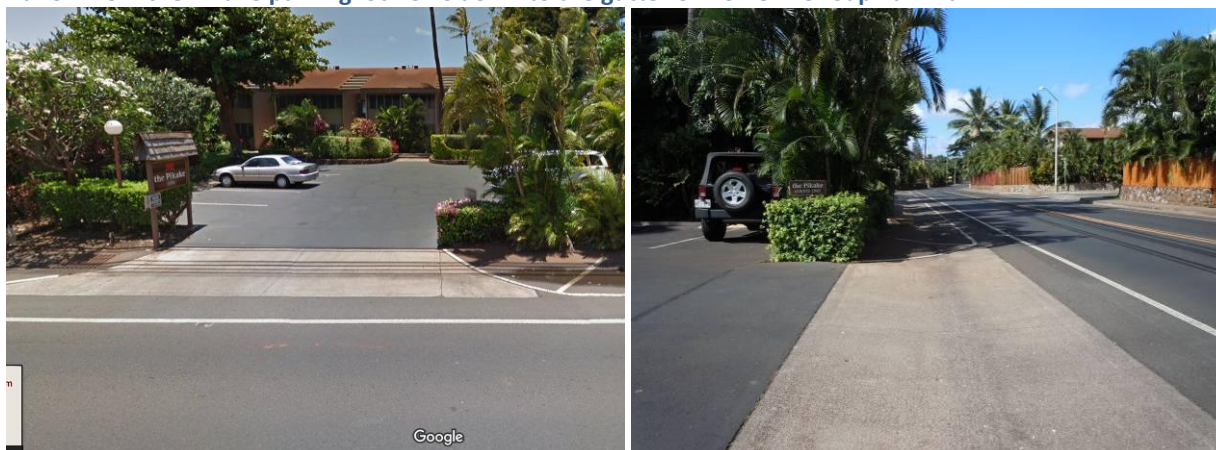
The Pikake is a condominium complex constructed in 1966 where the front portion of the property drains toward Lower Honoapiilani Rd while the back portion drains toward the ocean. The portion of the site in our watershed is 0.29 acres that is 65% impervious.

Runoff from the Pikake parking lot flows down to the gutter on Lower Honoapiilani Rd.

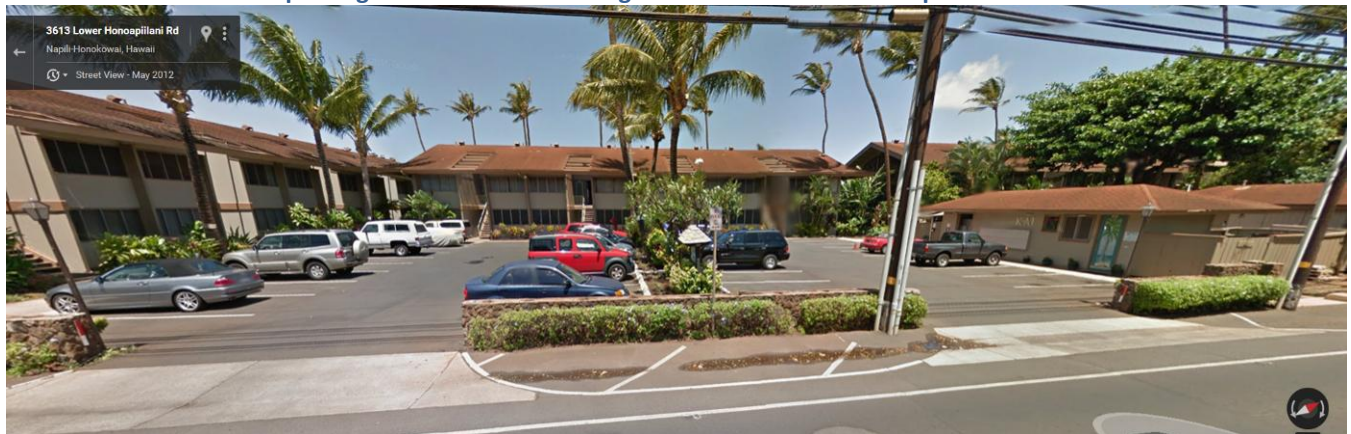
Runoff from the Hale Kai parking lot flows down to the gutter line on Lower Honoapiilani Rd.

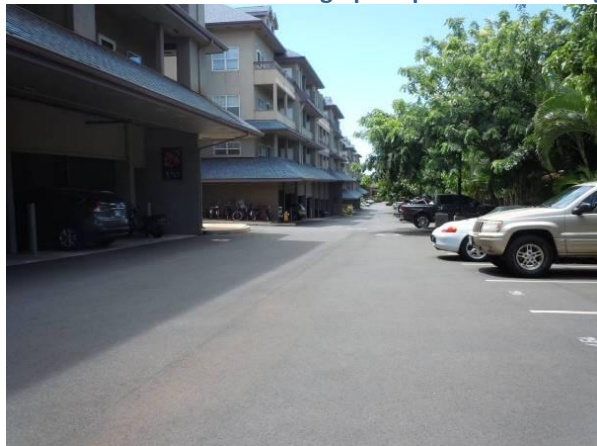
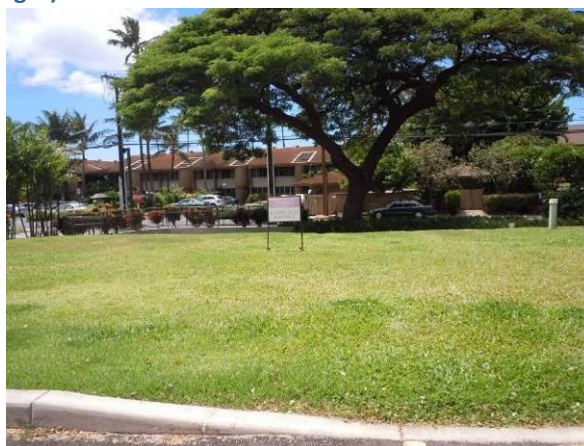
Downspouts from the roofs direct runoff onto the parking area (left); another building is slated to be constructed on the remaining open space at this site (right).

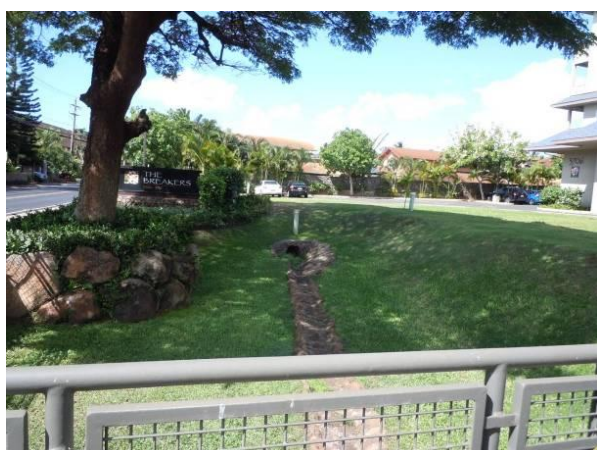
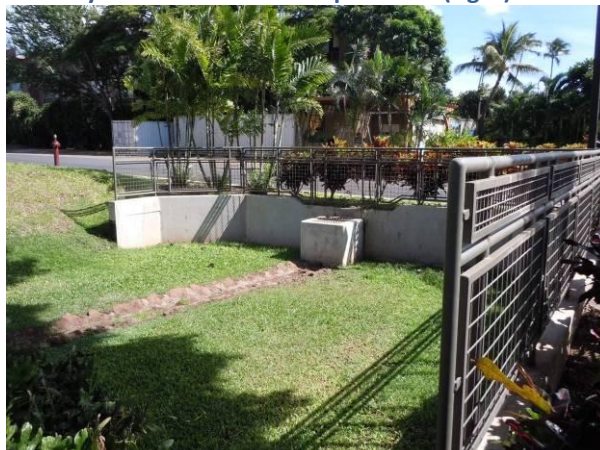
An extended dry detention basin helps manage runoff from The Breakers (left); a concrete outlet structure controls flow rates out of the basin and into the storm drain system in Lower Honoapiilani Rd (right).

The Breakers is the newest development in the watershed (2008) and has the only observed stormwater BMP – an extended detention basin. There is a total of 2 acres of impervious cover that contributes runoff to the small basin immediately adjacent to Lower Honoapiilani Rd. This includes almost 1 acre of roof top that is directly connected to the parking area via downspouts discharging to the pavement. Runoff is collected by a series of catch basins and directed into the detention basin. Low flows are conveyed with a hardened (appears to be a mortared rock base) low-flow channel with little to no detention before flowing out the orifice in the overflow structure. Runoff from larger storm events will be detained in the basin until the water reaches the top of the overflow structure, where it will flow through the grate and into the storm drain system in the road. The proposed retrofit for this site is to enlarge the existing basin utilizing the open lawn next to the basin (currently slated for future development), providing water quality treatment features such as a sediment forebay for pretreatment, longer flow path for low flows, wetland vegetation to filter and take up nutrients, and greater flood storage for larger events. In addition, the rooftop runoff should be collected in cisterns and reused as much as possible. Allowing the clean roof runoff to flow over a parking lot, picking up all the associated pollutants, is a lost opportunity. This could also provide a good example for other developments in the watershed – almost all buildings have gutters and downspouts for roof runoff, and yet no cisterns or rain barrels were observed. This project does have potential for public education given its location next to the main road, but it is a private development where future buildings are proposed, presenting an implementation challenge.

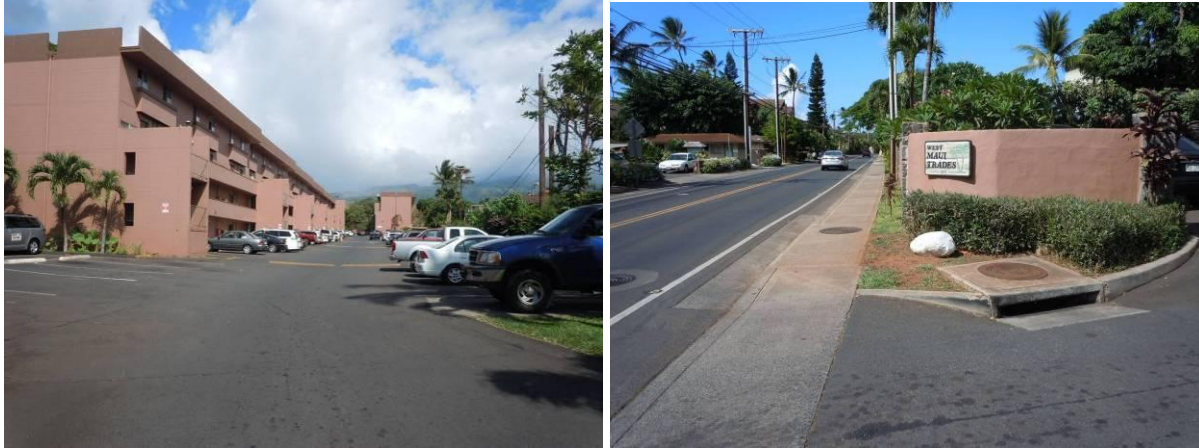
West Maui Trades is a 1.8-acre property that was developed in 1978. The site is over 80% impervious with a steep parking area. The rooftop runoff appeared to be directed to the parking area, and no stormwater infrastructure was visible anywhere on site. All runoff appears to enter the Lower Honoapiilani Rd drainage system via curb inlets near the road.

Runoff from West Maui Trades flows down the steep parking area to curb inlets near the road.

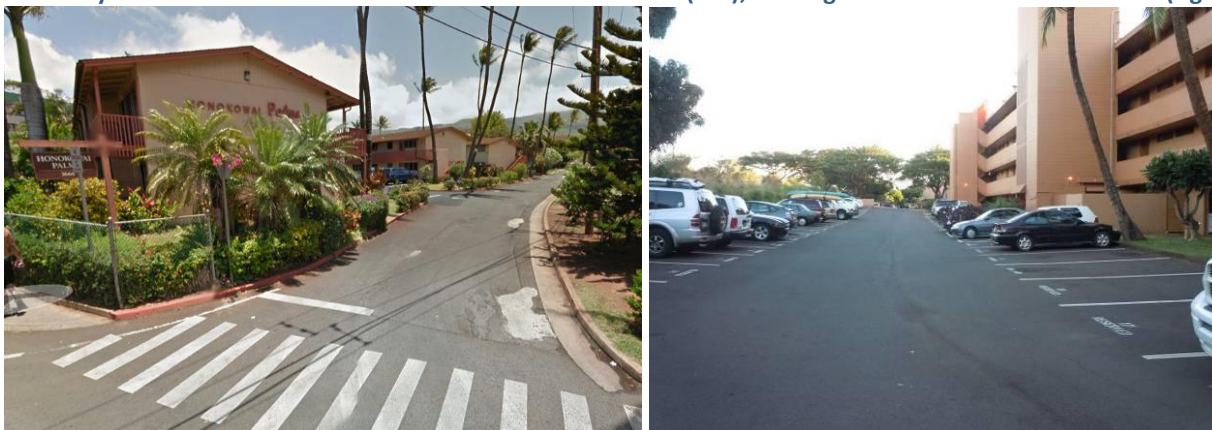
Honokowai Palms and Honokowai East are two condominium complexes accessed by the same driveway. Both have large expanses of parking and rooftops, as well as outdoor pools. Honokowai East also has a large tennis court, accounting for over 20% of its land area. No stormwater infrastructure was visible for either of these properties, so it is assumed that all runoff flows down the driveway to Lower Honoapiilani Rd.

Driveway entrance to Honokowai Palms and Honokowai East (left); Parking area behind Honokowai East (right).

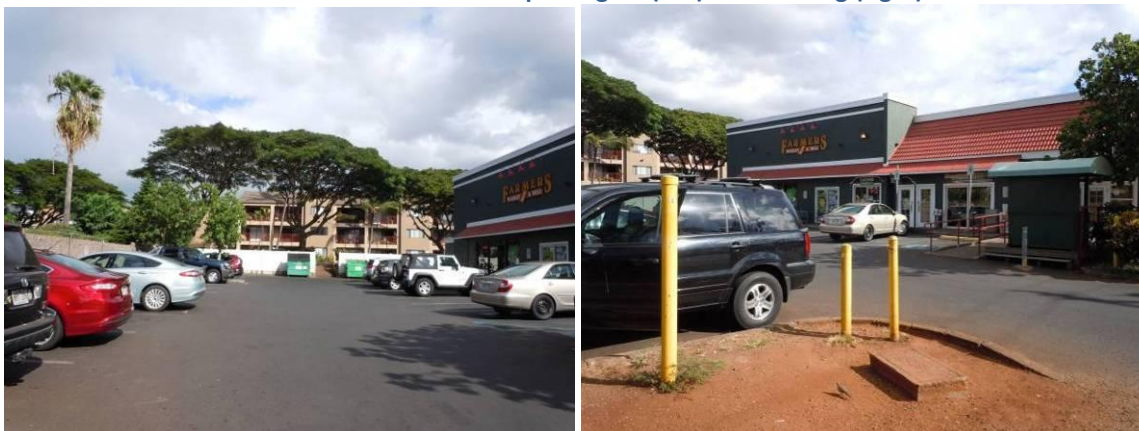
The Farmer's Market Plaza is one of only two commercial properties in the study area. This area was developed in 1975 and hosts an outdoor market three days a week, as well as an indoor market open all week. There are also a few shops in the front of the building along Lower Honoapiilani Rd. There was no visible stormwater infrastructure, and it appeared that the parking lot and rooftop runoff drains overland into the road and catch basins adjacent to HBP parking lot.

The Farmer's Market Plaza parking lot (left) and building (right).

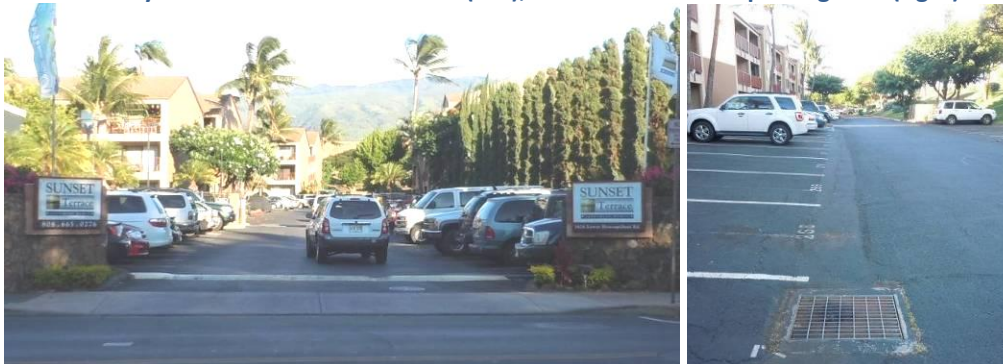
Sunset Terrace is the largest development in the entire watershed. It was built in 1987 and is comprised of 12 condominium buildings, surrounded by parking areas. There is one pool on the property, as well as landscaping between and behind the buildings. This property has its own drainage network of a series of catch basins and storm drains that discharge into HBP-2, but there are no stormwater practices visible for water quality or flooding control.

Driveway entrance to Sunset Terrace (left); catch basin in back parking area (right).

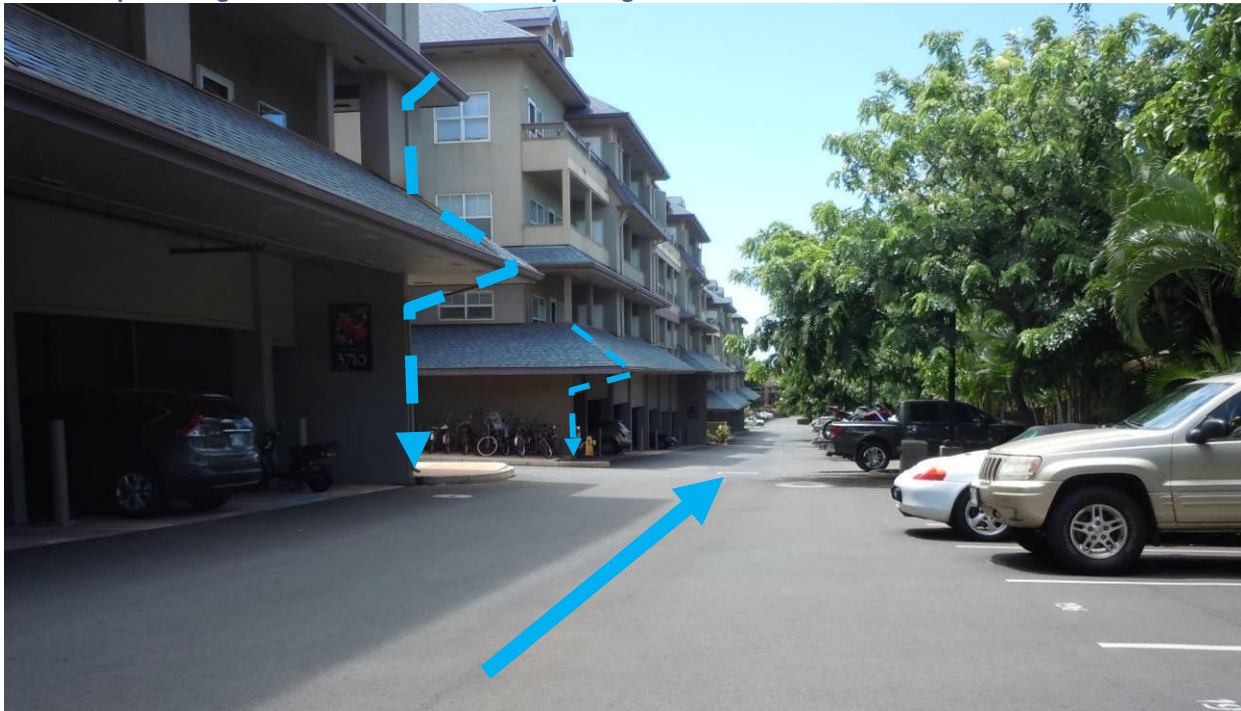
Looking down the parking area at The Breakers. A few of the downspouts are shown with blue arrows – all of the rooftop discharges in a similar manner to the parking area.

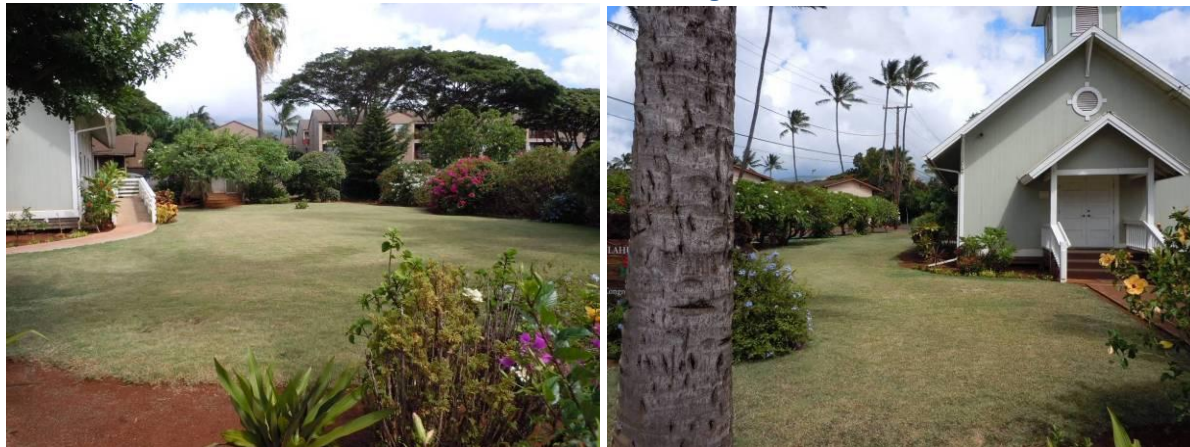
R-3: Lahuioikalani Church Rain Gardens

Sufficient space is available on both sides of the church for rain gardens.

The Lahuioikalani Church is an historical property owned by the Hawaii Conference of the United Church of Christ. Due to its prominent location along Lower Honoapiilani Rd and large pervious areas, this site is a great location for one or more demonstration rain gardens. The 2,000 sf rooftop has gutters that discharge to the lawn area via downspouts. While this roof is not contributing significant levels of pollutants, if any, to the HBP Channel, it does provide sufficient space and visibility for an effective demonstration project. If educational signage is allowed here, this project could have the potential to reach countless residents and visitors. While the ownership of this property and the historical nature of the site could present challenges to this project, the Hawaii Conference of the United Church of Christ could be a very valuable partner and proponent for this project and others in the watershed.

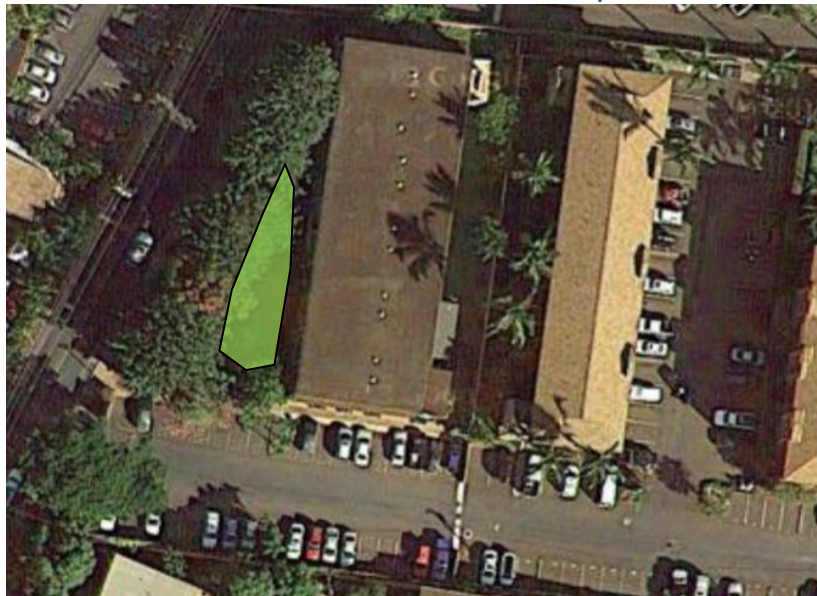
R-9: Leinani Apartments – Bioretention Area

A bioretention area could be constructed at Leinani Apartments as shown below in green.

There is a triangular-shaped lawn area in front of Leinani Apartments that could be used to treat stormwater runoff from the rooftop as well as a portion of the parking area/driveway. The proposed retrofit is to construct an 800 sf bioretention area between the apartment building and Lower Honoapiilani Rd to treat runoff from 0.5 acres of roof and parking. This is one of the few properties that has available open space in an area well-positioned to accept stormwater runoff (i.e., downgradient from the contributing drainage area), but it is a private development, which could make implementation challenging and reduces the public education value of this site.

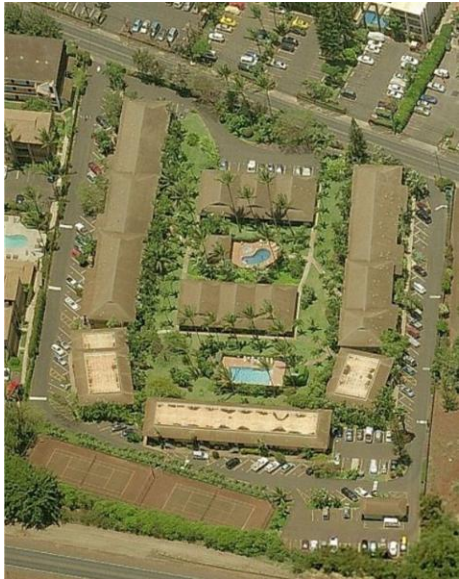
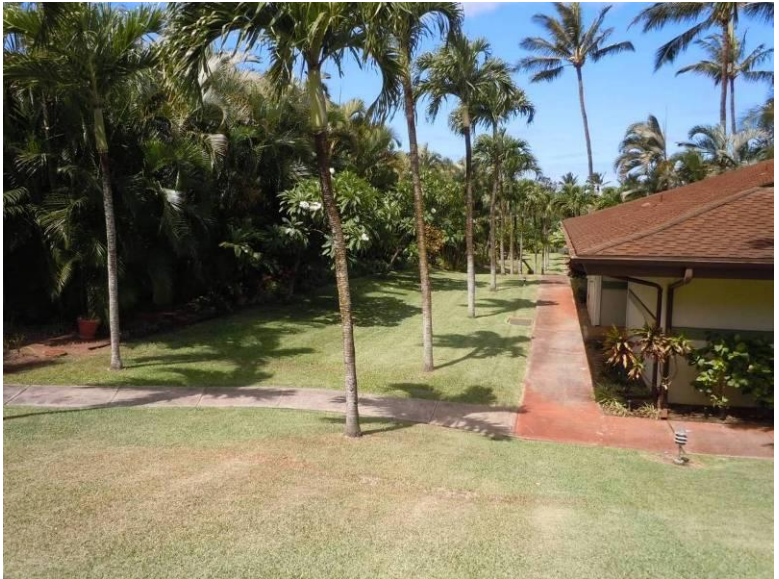
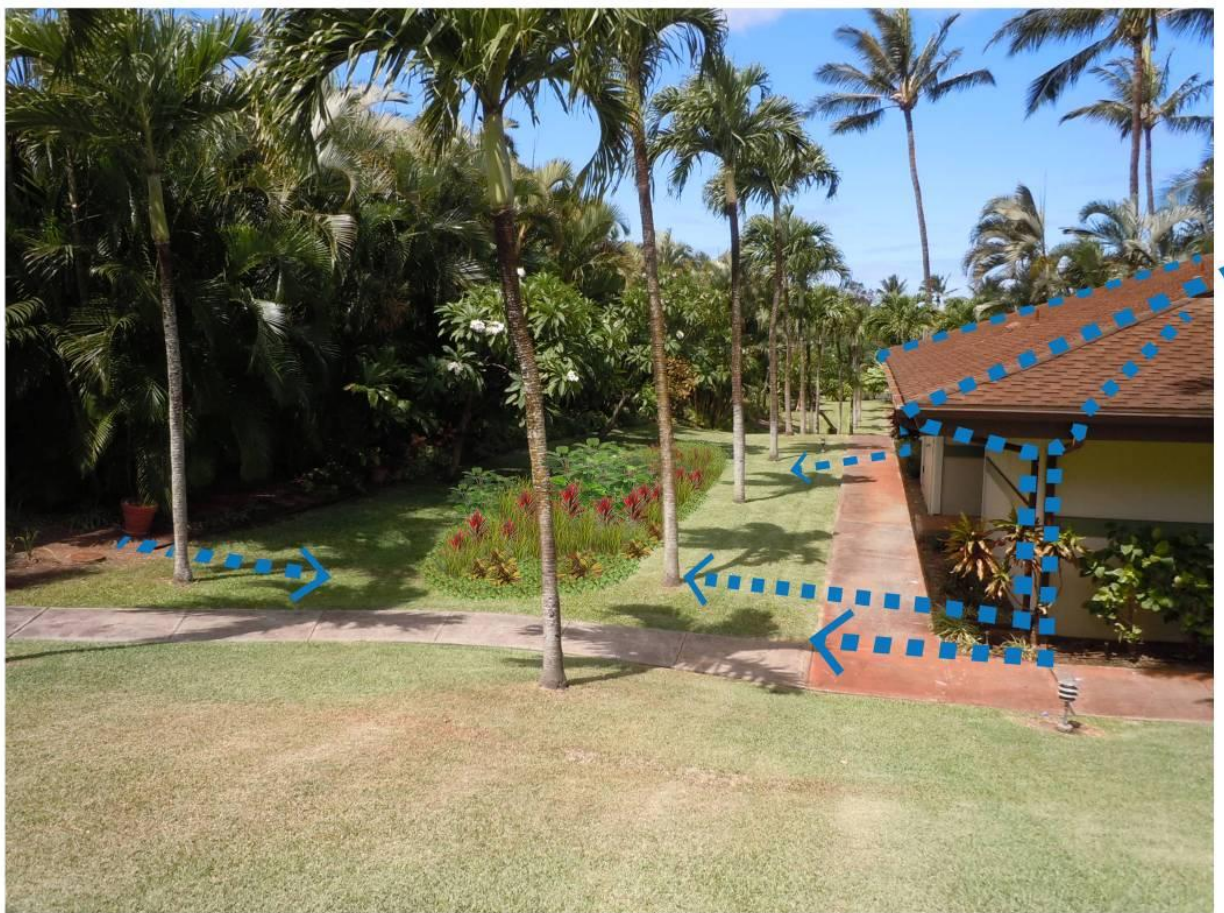
R-10: Hale Royale – Bioretention Areas

An overview of Hale Royale, showing the parking areas surrounding the buildings, with a courtyard in the middle (left); looking down one of the grassed courtyards (right). Below is a graphic rendering of one of the proposed bioretention areas.

Hale Royale is a rare condominium complex for this watershed – it has landscaped areas incorporated throughout the site, providing many opportunities to integrate stormwater management. Currently, the rooftops discharge to either the steep parking areas toward the outside of the site, or into the grassed courtyard. At a minimum, the courtyard runoff could be directed into bioretention areas that slow, filter, and infiltrate the stormwater. Bioretentions are proposed vs. rain gardens because of the steep grade in the courtyards that will require a stepped system. Depending on how much space the condominium is willing to convert for this purpose, it would also be possible, but much more complicated, to direct some of the parking area runoff into these systems. For simplicity purposes for this study, we have assumed that the bioretention areas will only be sized for the runoff currently flowing into this area (0.7 acres of rooftop). Thus, the bioretentions only need a surface area of 1,100 sf while much more is actually available. This private property may be reluctant to voluntarily take on this project, and the public education potential is mostly limited to the Hale Royale residents. However, this is a site where the bioretention areas could really become integrated in the beautifully landscaped courtyards, providing a great example for other developments in West Maui.

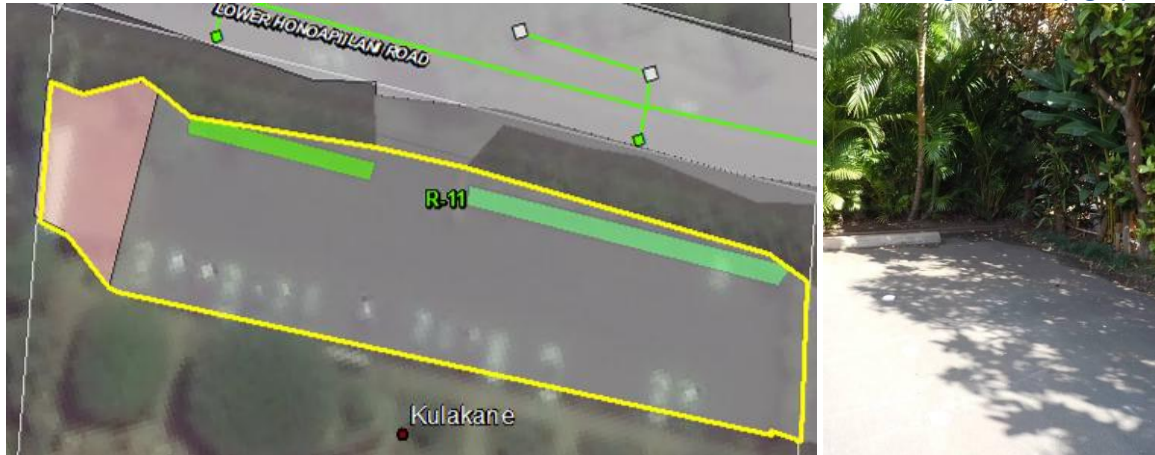
R-11: Kulakane Bioretention

The Kulakane parking lot currently drains toward the mauka edge of the lot, along the curb, and out to Lower Honoapiilani Road along the southeastern corner with no treatment. The proposed retrofit is to utilize the existing flow path by converting the edge of the parking lot into a narrow bioretention swale. This practice would remove 1,000 sf of pavement and treat 0.3 acres of impervious cover. This development is private, which may make this retrofit difficult to implement, and public education is mostly limited to the Kulakane residents.

The drainage area and BMP footprint for this site is shown below (left); the existing low point in the parking lot is where overflows from the bioretention areas would be directed to the road drainage system (right).

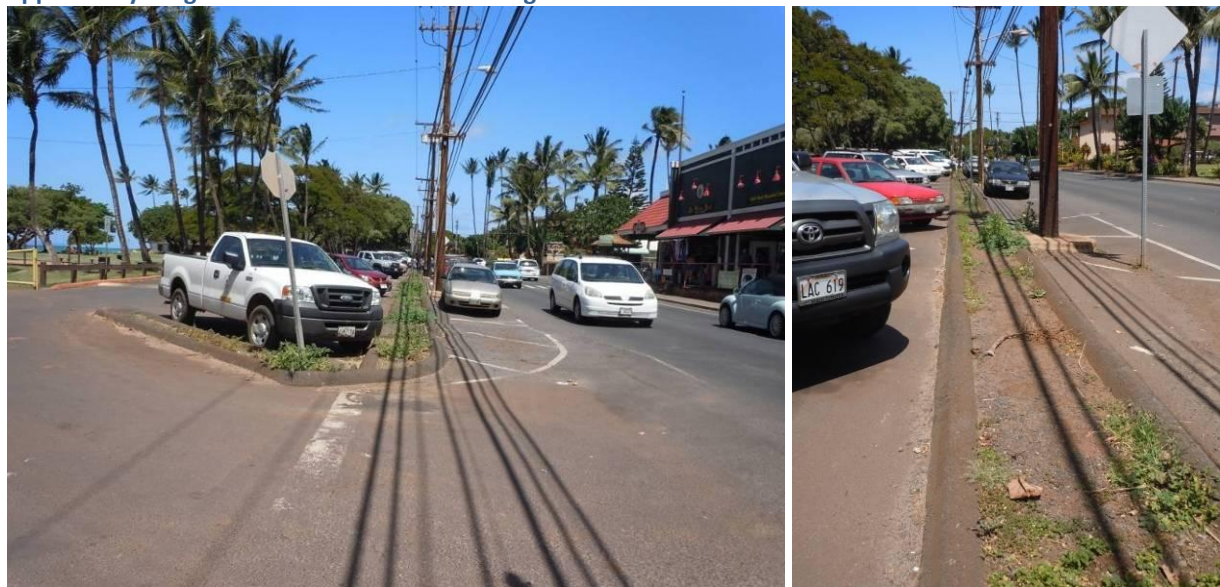
R-2: HBP Parking Lot/Lower Honoapiilani Rd Green Streets

The stretch of Lower Honoapiilani Rd in front of HBP is heavily used, particularly for people going to the Park as well as the Farmer's Market and adjacent businesses on the mauka side. The road is superelevated here, sloped from mauka to makai, with a gutter line and catch basins along the edge of the HBP Parking Lot. Thus, the drainage area includes much of the HBP Parking Lot, all of the roadway, and the runoff from the Farmer's Market Plaza (1.8 acres, 67% impervious). Because parking is in such a demand here, it is important that this design maintain all of the parking spaces in the lot as well as along the road. There are utilities in this area to work around as well, such as utility poles, water, and sewer. However, the small island in between the road and parking lot, along with the areas striped for no parking, can be converted for stormwater management (1,600 sf pavement removal). Due to the overhead wires and to maintain views of the ocean, this design would not plant trees, instead using a variety of aesthetic and low maintenance grasses and shrubs. This project would occur mostly within the right-of-way (ROW), which is Maui County DPW ownership; although, Maui Parks and Recreation would also need to participate as a portion of the project would occur on the parking lot for HBP. This site has one of the highest public education potential of any in the watershed given its prominent location near a popular commercial area, a park, and within sight of the waters the project would help protect.

The island and no parking zones between the HBP Parking Lot and Lower Honoapiilani Rd provide an opportunity for green street stormwater management.

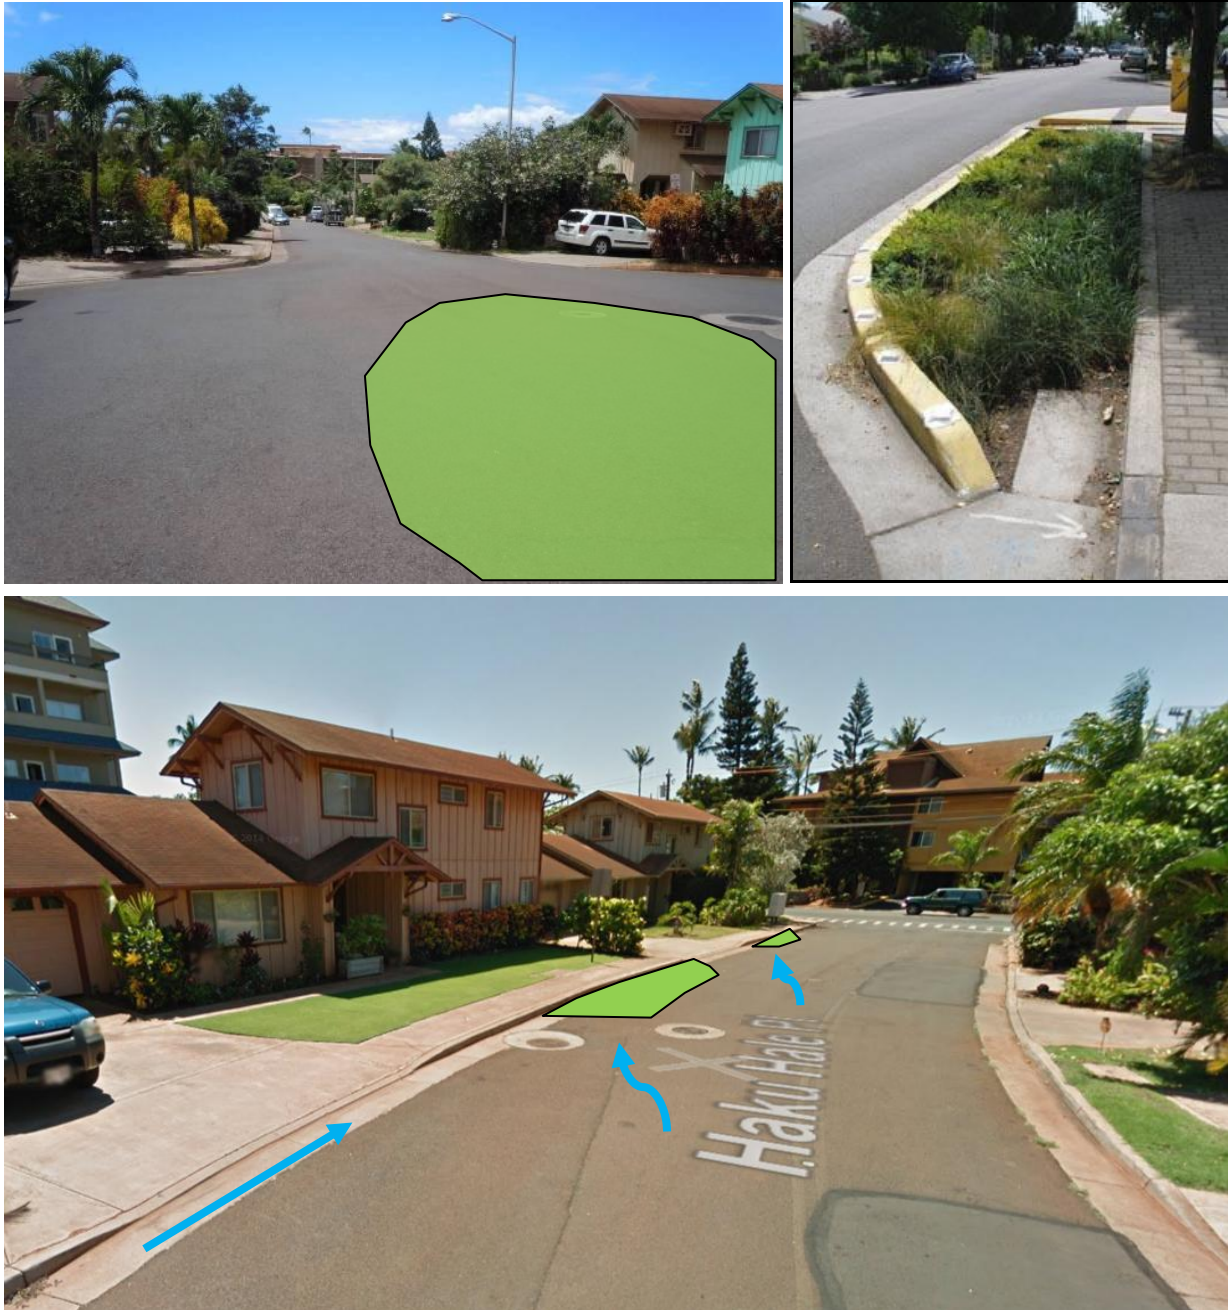
R-8: Haku Hale Place Green Streets

Looking down Haku Hale Place from the cul-de-sac turnaround with the bioretention footprint shown in green (left); and an example of a stormwater bump-out (right). Bump-out locations shown in the parking lane near Lower Honoapiilani Rd (bottom).

The proposed retrofits include (1) removing 600 sf of pavement in the center of the cul-de-sac and installing a bioretention area to treat runoff from the road and upgradient driveways and rooftops; and (2) removing 1,200 sf of parking lane to construct green street “bump-outs” at key locations. Overflow from these practices would be directed into the existing storm system. This project is located within the public ROW, but public education potential here is mainly for

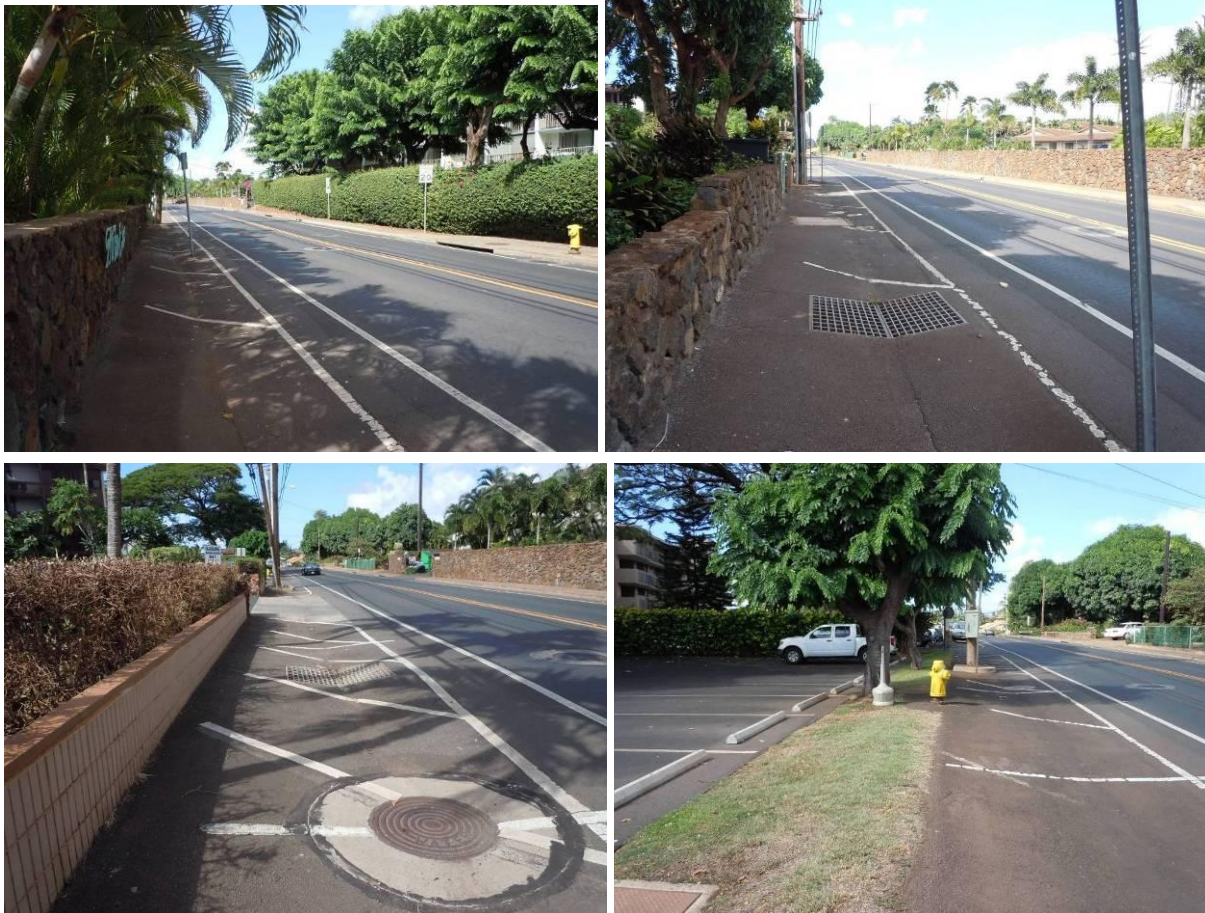
R-12: Lower Honoapiilani Rd Green Streets

There are several no parking paved areas along Lower Honoapiilani Rd that could be converted for stormwater management. The design would need to work around other existing utilities such as water and sewer.

limited parking (mostly striped for no parking), and a gutter line that directs stormwater into catch basins. The makai side presents an opportunity for better stormwater management. The paved shoulders that are striped for no parking (2,200 sf pavement removal) can be converted into stormwater swales with low maintenance grasses that slow, filter, and infiltrate runoff. The existing stormwater drainage system would be left in place for overflows from larger stormwater events to ensure the road does not flood. These swales would manage runoff from the makai half of the road and the portions of the adjacent properties that drain to the road (0.5 acres). This project is located fully within the public ROW (Maui County DPW property), and has high public education potential.

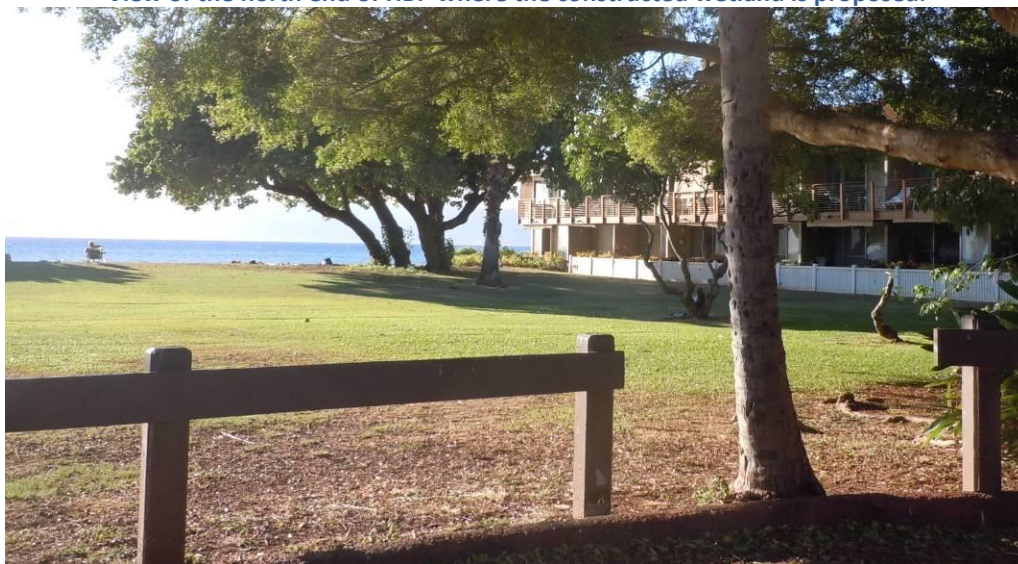
R-1: HBP – Constructed Wetland

View of the north end of HBP where the constructed wetland is proposed.

However, there was more space available along the northern end of the park for a constructed wetland. In this retrofit scenario, stormwater runoff from the small rain events would be diverted from the 7' x 1.5' box culvert (HBP-1) first into a pretreatment chamber to remove trash and sediment before flowing into a shallow constructed wetland. This wetland would treat runoff from 20 acres (62% impervious). At roughly 1.5% of the DA, the constructed wetland would need to be 13,000 sf at a minimum to treat the entire 1-inch water quality volume. Given the already limited space in this busy park, the constructed wetland was sized to treat only 0.5 inch with the goal of implementing additional retrofits at other sites in the same drainage areas. The constructed wetland was designed to avoid impacts to large shade trees in the park, to maintain pedestrian pathways with a boardwalk, and to provide educational signage. On-site discussions with Maui DPW and Parks and Recreation led to some minor tweaks in the design. However, follow-up discussions determined that the proposed retrofit would take up too much of the park's space. This project is still a part of this plan because it is by far the most effective retrofit opportunity in the watershed. There may come a time when integrated stormwater management becomes a more important piece in all of the public parks where there is accessible open space typically lacking on private lands.
